AGENDA

Historic District Commission Meeting

6:00 PM - Monday, May 9, 2022

**RE: Inspection of Wall Damage
14 West Main Street
SPECS Project No. 5563**

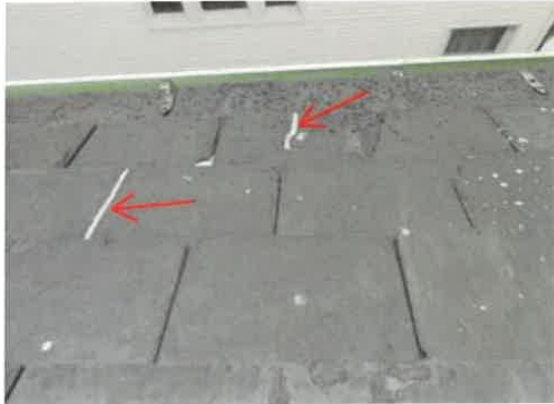
Photo 8-1

Substandard repairs were found at one or more locations on the roof surface. Leaks can occur as a result. This is a conducive condition for wood-destroying organisms. Recommend that a qualified contractor evaluate and repair per standard building practices.

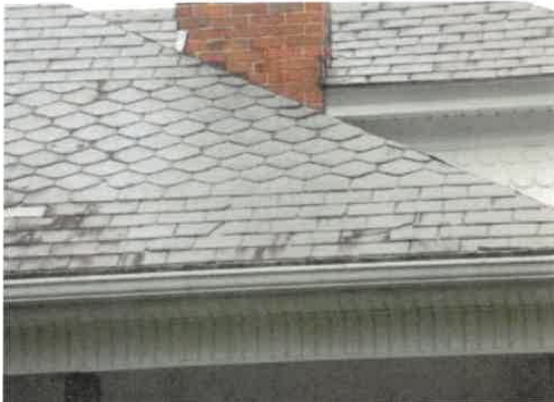
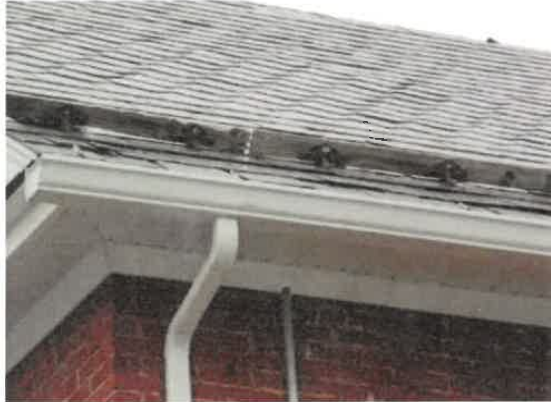
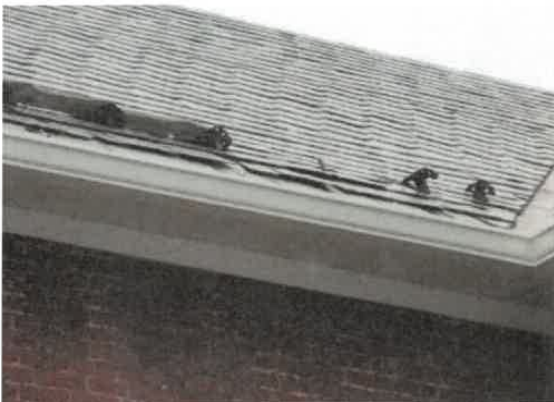
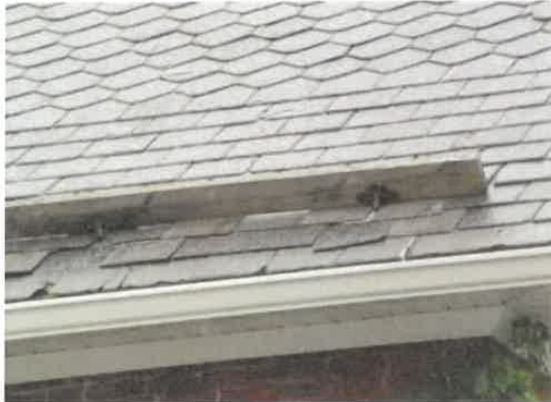
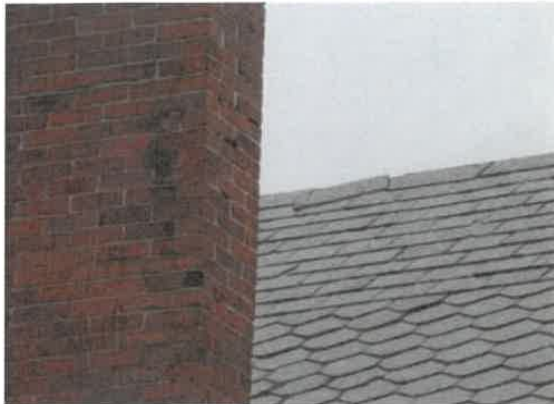
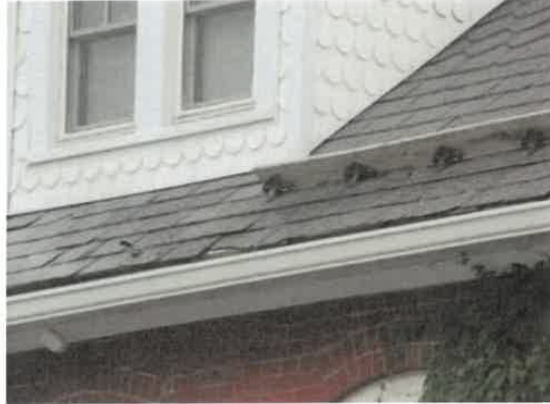
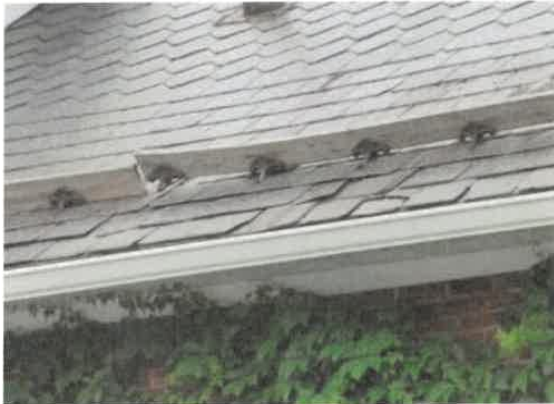
Many slate roof tiles were broken, chipped and/or missing. Leaks may occur as a result. This is a conducive condition for wood-destroying organisms. Recommend that a qualified person replace tiles or make repairs as necessary.

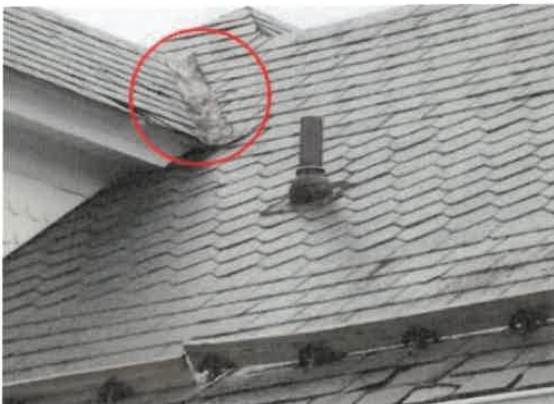
Photo 10-1

One or more roof flashings were substandard. Leaks can occur as a result. This is a conducive condition for wood-destroying organisms. Recommend that a qualified person repair as necessary.

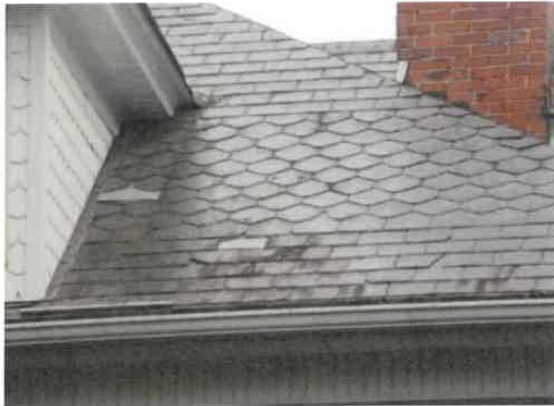
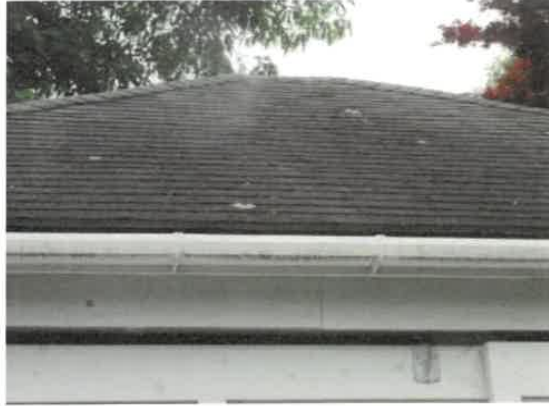
Moss was growing on the roof. As a result, shingles can lift or be damaged. Leaks can result and/or the roof surface can fail prematurely. Efforts should be made to kill the moss during its growing season (wet months). Typically, zinc or phosphate-based chemicals are used for this and must be applied periodically. For information on various moss treatment products and their pros and cons, visit: <https://www.reporthost.com/?MOSS>

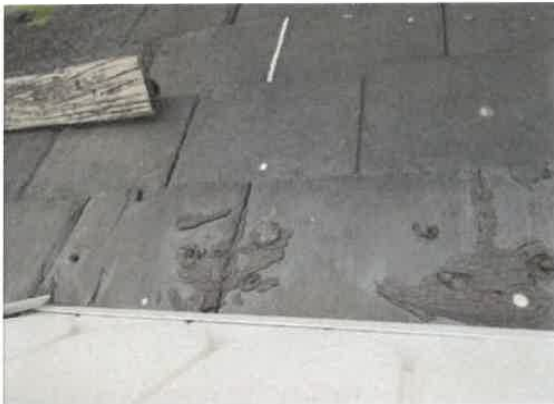
Photo 12-1

Nail heads were exposed at one or more shingles. More than just a few exposed nail heads may indicate a substandard roof installation. Recommend applying an approved sealant over exposed nail heads now and as necessary in the future to prevent leaks.

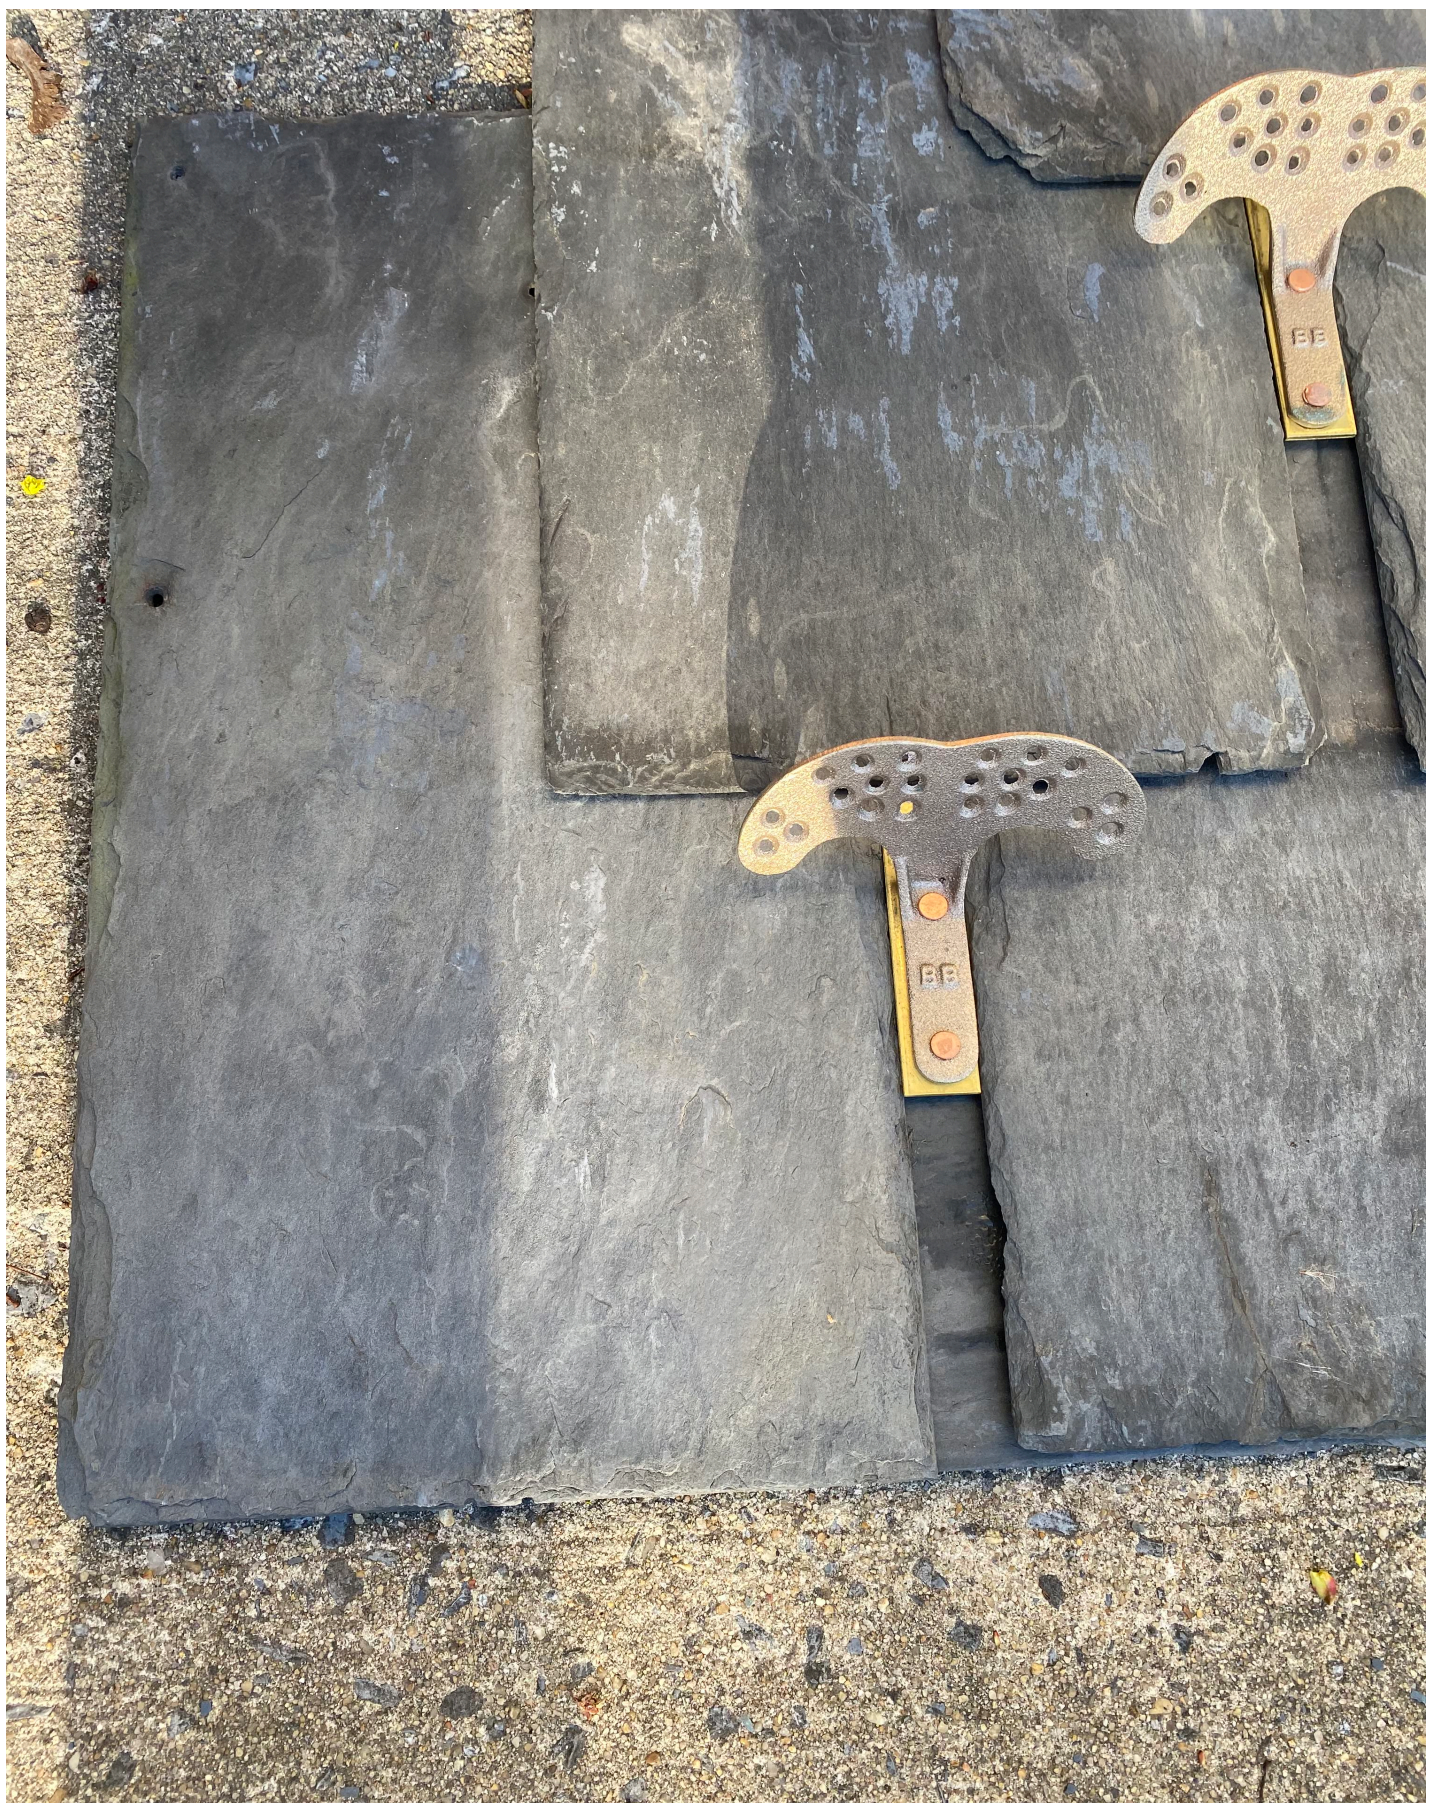
The masonry (brick or stone) veneer was deteriorated or damaged in some areas. Where cracks or openings are exposed, water can enter the wall structure causing mold, fungal growth and structural damage. This is a conducive condition for wood-destroying organisms. Recommend that a qualified contractor repair as necessary. For example, by repointing mortar or replacing broken or missing masonry.

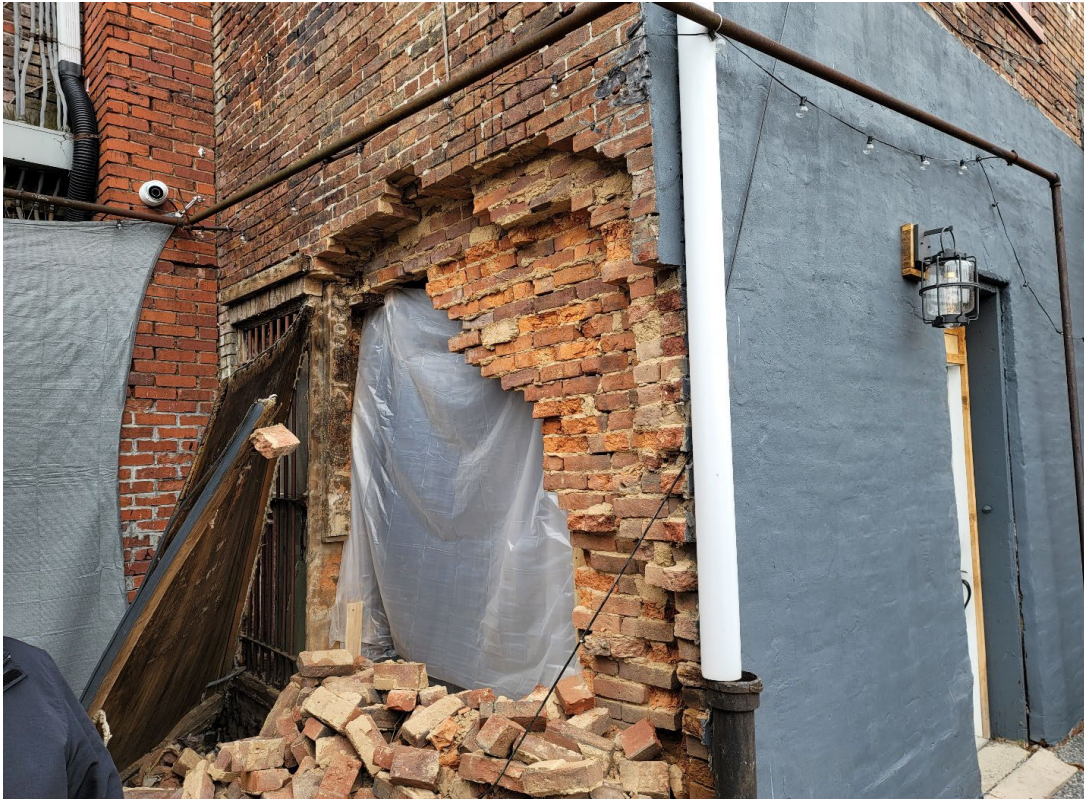
At your request, on April 5, 2022, I performed a visual inspection of the structure at 14 West Main Street specifically to look at a wall collapse in the rear of the building. I was accompanied by Rick Gornall of Gornall Construction, Inc., and Chris Schott of C&S Pyramid Builders, Inc. The structure is a multi-level brick building built in the early 1900's. It is my understanding that on the weekend prior, the wall collapsed during a wind event. See Photos 1 and 2. No one was injured.

Photo 1. View of rear wall at collapse. Note window to the left of collapse.

The repair of the wall will require temporary shoring because the apartment above is occupied. The wall at this time appears to be in equilibrium but further exposure to severe weather could change this status. Shoring will need to begin in the basement. I recommend pouring a 6-8" thick mud slab with 3000 psi concrete on the existing floor in the basement just clear of the existing terracotta sewer pipe. From there, heavy 6x6 timbers or screw jacks should be placed on 6' centers along the damaged wall. All timbers shall be rough cut oak or stronger. Use a header of 8x8 timber placed under the floor joists. Add blocking between the header and floor above. The second story should be shored in a similar fashion. Instead of a mud pad, it is recommended that a 3" thick sill plate be installed on the floor. The columns should line up with the solid blocking below. This will need repeated to the third floor. The roof will not need shored unless additional cracking or loosening of the bricks below the roof joists are observed.

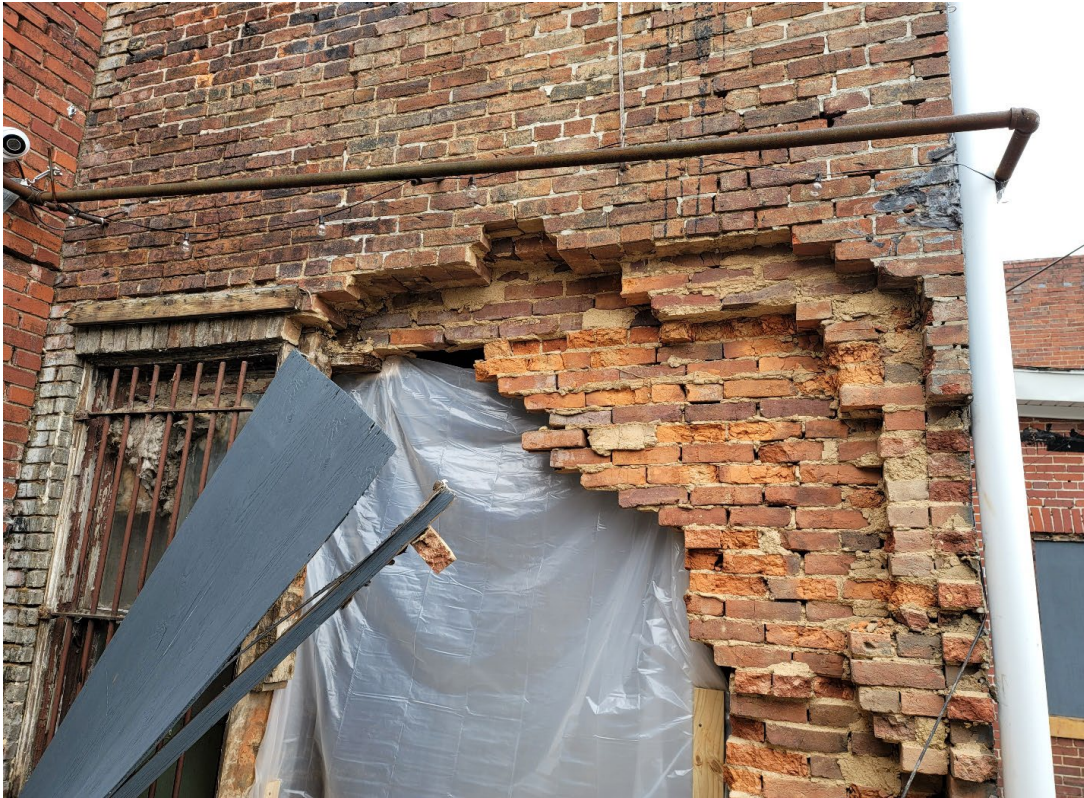
Photo 2. Another view of collapsed wall.

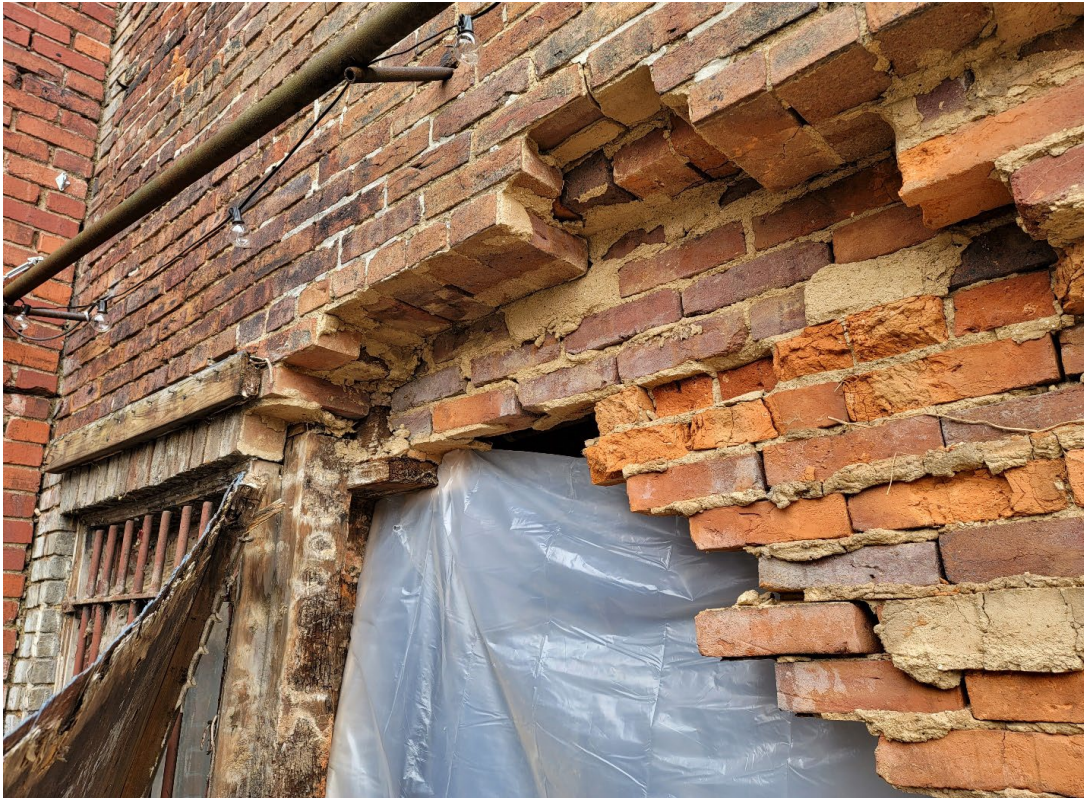
The building is constructed of composite multi-wythe masonry laid in an American common bond with headers every six rows. There were three wythes of masonry at the point of failure. See Photo 3. It is my understanding that there was a window at the point of failure. The masonry wall showed signs of water intrusion. Photo 4, taken at the corner of the building next to the downspout, shows delaminated interior brick, missing or compromised mortar joints and disintegrating interior brick. The exterior brick appears to be harder than the interior wythes as was typical for brick buildings of this era. There was staining and eroded mortar on the wall next to the downspout on the wall above. See Photo 5.

Photo 3. This view shows the side of the existing window. It is my understanding that there was a second window adjacent to it. Notice the delamination in the interior wythe.

Once the shoring is in place, the mason should be able to work on the brick on the first floor. It is recommended that the existing first floor windows be eliminated. The exterior brick can be cleaned and reused. The existing mortar should be tested to determine type and composition. Caution on the sampling, as it appears modern Portland based mortar was used at one time to repoint part of the wall. The brick should also be tested for hardness. The mortar should not be harder than the brick used. Most likely the mortar is lime based. Depending on testing, lime-based mortar shall be used with any joints using existing brick. The interior bricks can either be laid with a common bond with headers or with concrete masonry units (cmu's) at the owner's discretion. If cmu's are used, then install false header bricks and use brick ties to secure the face brick. Note, interior brick should not be interchanged with face brick. It is recommended that the repair be extended at least four feet around the corner of the building for the first floor. Actual repair may vary. The intent would be to get past the zone of deteriorated interior bricks. Work around the corner should not proceed until the first area is repaired to minimize loose brick above. It is also recommended that the wall face above the corner near the downspout as shown in Photo 5 be repointed.

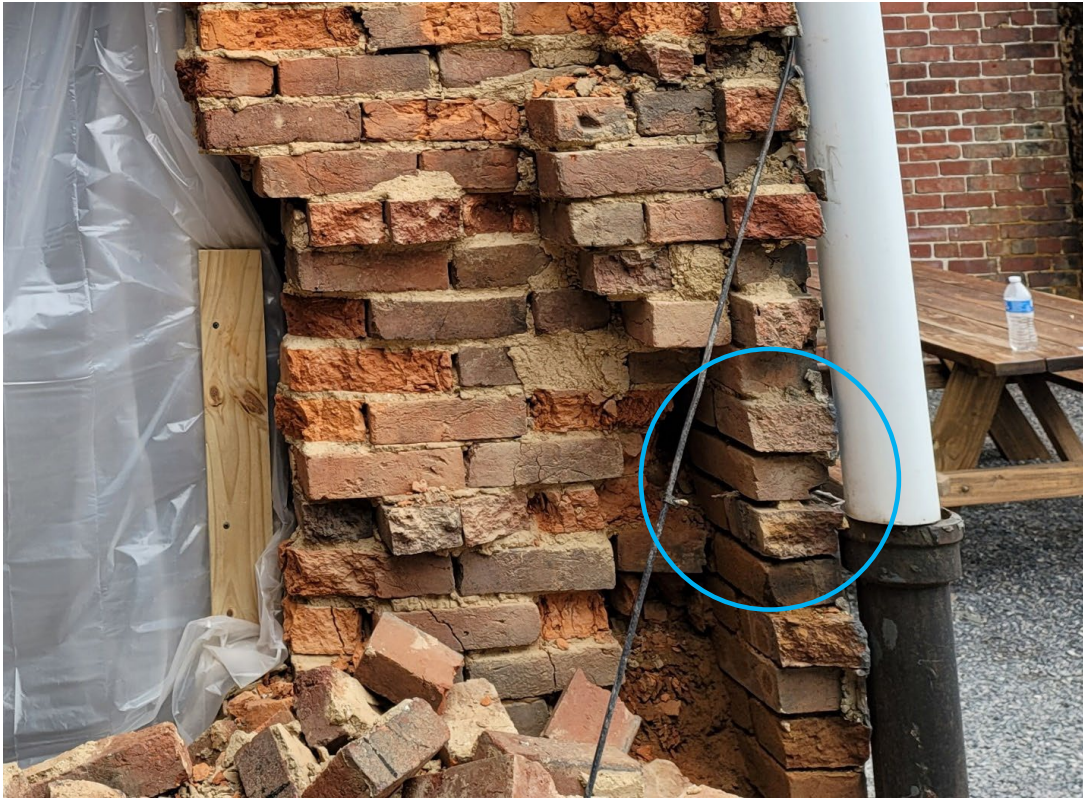
Photo 4. Detail of brick at corner. Interior brick fell apart at the touch. The arrow points to severely damaged brick. Note loss of mortar in exterior brick circled in blue.

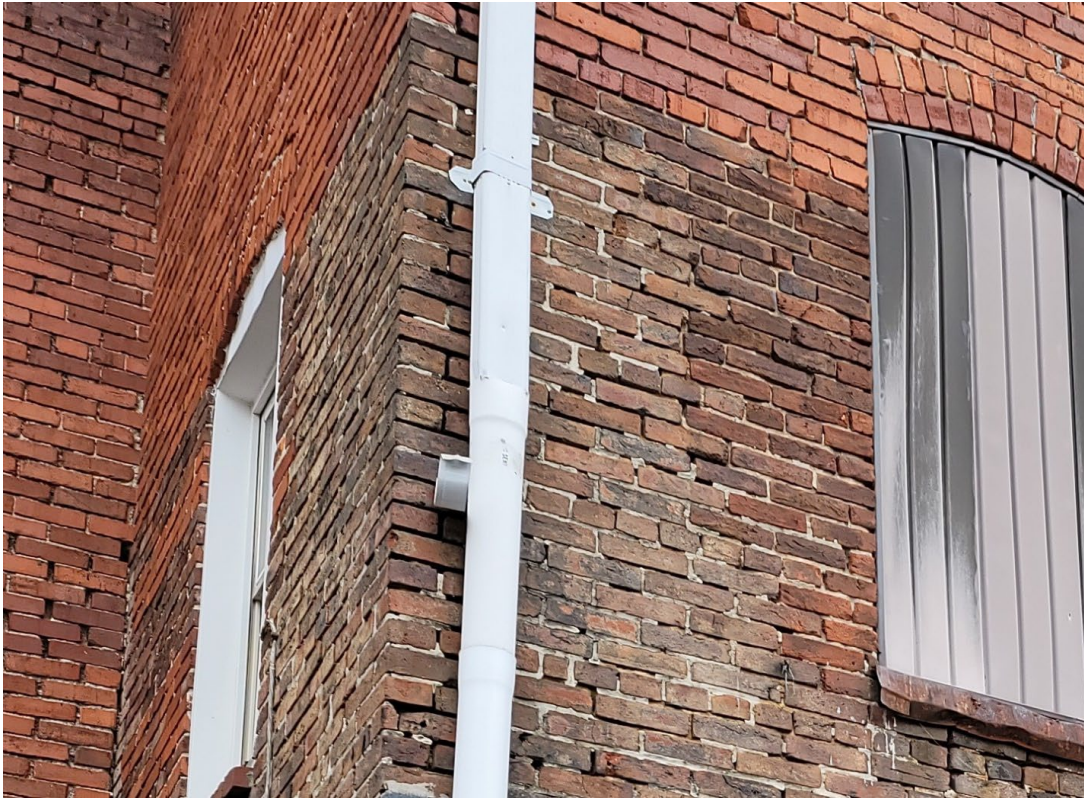
Photo 5. Note loss of mortar and staining at the corner of the wall near the downspout.

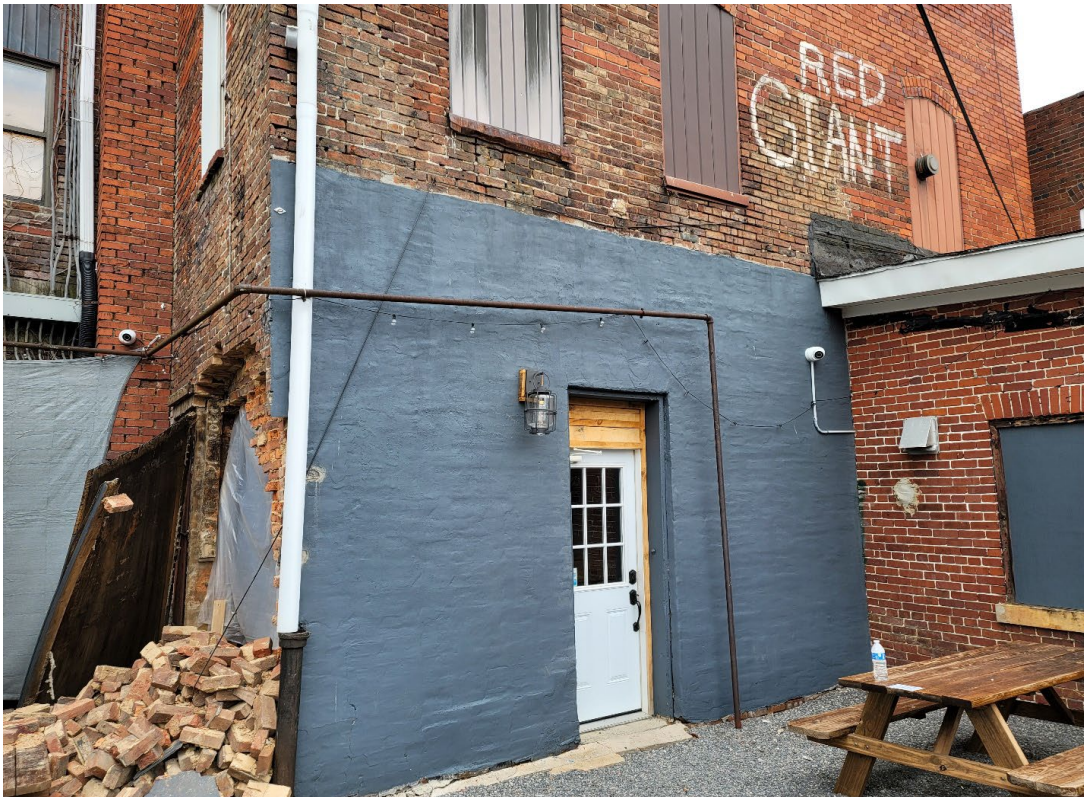
The back wall adjacent to the collapse appears to have been recently painted. It also appears to have been parged. See Photo 6. Painting and parging historic brick walls is not recommended as the finish traps water in the wall and prevents it from escaping.

Photo 6. Rear of building adjacent to collapsed wall. Note wall was recently painted and appears to have been parged.

1. Repoint all mortar faces with appropriate mortar.
2. Examine the wall for points of water entry. These include window and other openings, the roof, and damaged brick above.
3. Remove or vent parging and painting on the exterior walls. Parging and painting can trap moisture and prevent the porous brick and mortar from drying out.
4. Verify roof drain is working. Consider adding heat trace to drains.
